Fortis² Sling

Fortis² Slings are heavy-lift, multipart slings made with our Unitrex™ XS Max Wear synthetic cable that has a core of Honeywell Spectra® fiber encased with neoprene and a tough braided jacket of high-tenacity polyester. The result is a heavy-lift sling of Unitrex™ XS that has the durability and stiffness of a wire rope sling at a fraction of the weight.

Fortis² Sling – Inspection Criteria

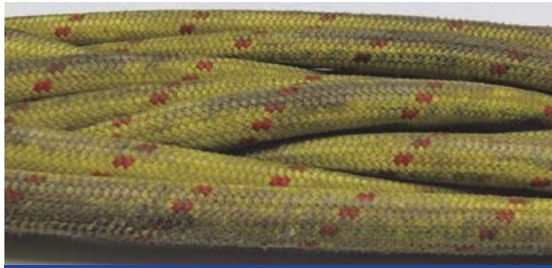
Sleeve Abrasion – No Action Required

Sleeve abrasion is typical of normal use even with proper care. When inspecting the sling look for areas of localized abrasion; seek to minimize localized abrasion by avoiding sharp bends or contact with abrasive surfaces. Localized abrasion can lead to sleeve failure requiring repair. Uniform sleeve abrasion does not affect sling capacity.

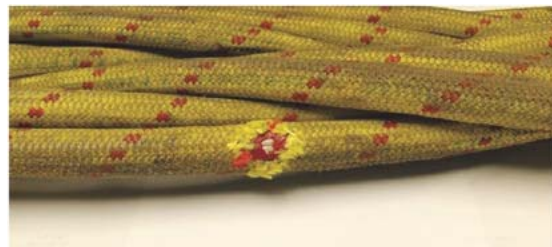
Damage Tape – Repairable

If inspection indicates damage to the red rubber tape there is a potential the load bearing core has been damaged. Carefully inspect the core for cut or frayed white polyethylene ends or any foreign contamination resulting from penetration of the rubber barrier. Foreign matter should be carefully removed to prevent internal abrasion of core ends. If no cuts or strand abrasion is apparent, the rubber barrier and sleeve can be fully repaired. Sling capacity is not affected.

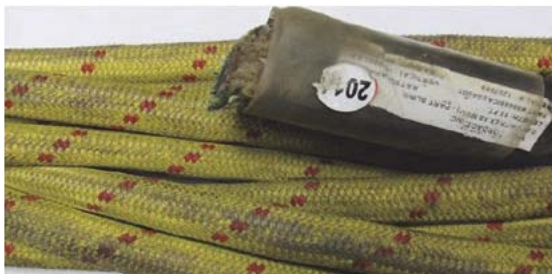
Tail Ends Movement – Requires Expert Evaluation

Fortis² Slings have a unique tail termination system; the condition of the tails can indicate possible overload or abuse. If the black cold shrink is absent, or if the green painted tails have been pulled through the cold shrink, the sling should be reserved for additional detailed inspection. Inspect the braided body of the sling to ensure all of the strands are equal in length; there should be no loops or imbalance. Look closely for any glazing or melting of the outer polyester jacket, particularly near the sling tails.

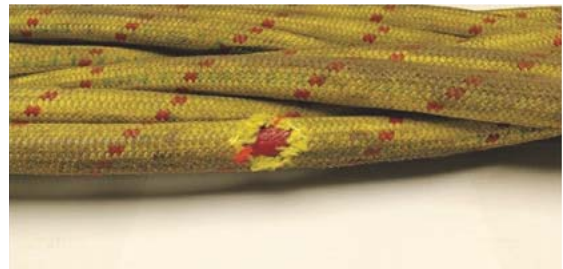
Parted Sleeve – Repairable

Broken sleeve strands result from either localized abrasion or contact with sharp edges. The damaged area should be thoroughly inspected to be sure the load bearing core strands have not been damaged. Fortis² slings have a red rubber barrier under the protective sleeve which is easily cut if the sleeve is compromised, thus indicating potential damage to the core. Inspect the red barrier; if it is intact and no white polyethylene strands are seen through the sleeve can be repaired. Sling capacity is not affected.

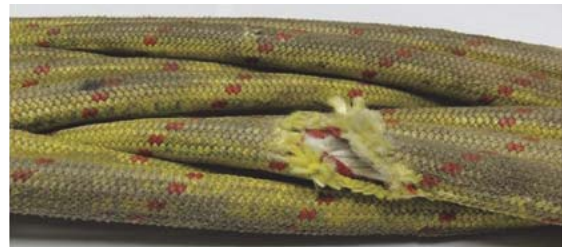
Cut Core Ends – Requires Expert Evaluation

Any damage to the sling that might compromise the integrity of the core elements should be carefully inspected. Any sling where damage to the core elements has occurred should be immediately removed from service and held for additional detailed evaluation. Depending on severity of the damage the sling can be repaired or permanently removed from service.

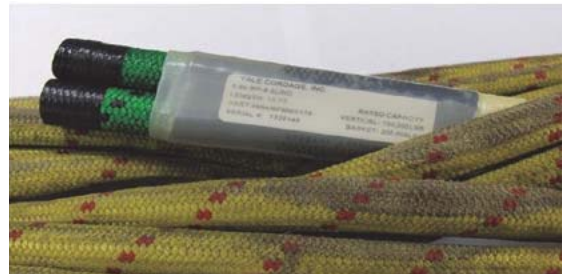
Ends can be repaired if body is not distorted

If neither are present, the sling tails can be repaired by replacement of the black shrink tube over the end of the tails. If any distortion of the braided body of the sling is observed the sling should be immediately retired from service for expert evaluation.
