8-STRAND PLAITED
INSPECTION

YALE CORDAGE

8 - STRAND PLAITED

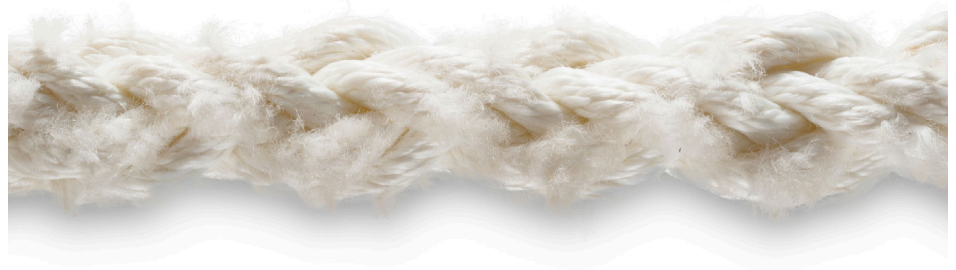
ABRADED SPOT

Not all abrasion is harmful. When small surface fibers break on a rope, they create a fuzzy texture known as “mild abrasion.” This is normal and can even protect the rope from further wear. Extremely abraded spots should be addressed.

Excessive abrasion can be caused by repeated contact with sharp edges or rough surfaces. While you should expect mild abrasion as you break in your rope, abrasion that doesn't stabilize after the first few uses might mean you're losing strength. Inspect for excessive damage by looking closely at the inner and outer fibers.

If you encounter an abraded spot with excessive damage, you can cut out and re-splice the section.

Always use slings when lifting, and avoid abrasive situations whenever possible, including rough surfaces and sharp edges. Keep your chocks, bits, winches, drums and other surfaces in good condition and free of burrs and rust.

Make sure sheaves are the right size and are free to rotate. Don't drag the rope over rough ground. And be sure to use clamps and similar devices with extreme caution.

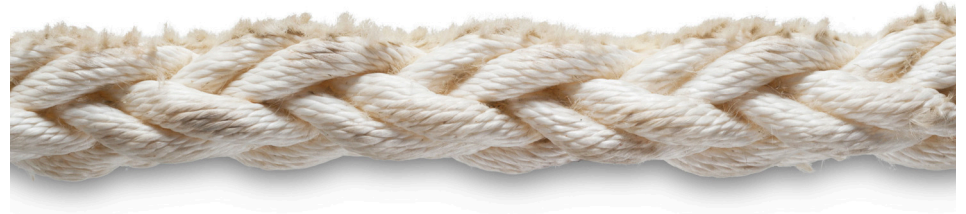
CUT STRAND

When visually inspecting your rope, always look closely for any cut strands. Any cut strands will cause some loss of strength, and two or more that are close together may mean the rope needs to be retired.

Cut strands could be caused by abrasion, sharp edges and surfaces, or cyclic tension wear.

If possible, remove the affected section and re-splice with an end-for-end splice. If re-splicing is not possible, retire the rope.

Always use slings when lifting, and avoid abrasive situations whenever possible, including rough surfaces and sharp edges. Keep your chocks, bits, winches, drums and other surfaces in good condition and free of burrs and rust.

Make sure sheaves are the right size and are free to rotate. Don't drag the rope over rough ground. And be sure to use clamps and similar devices with extreme caution.

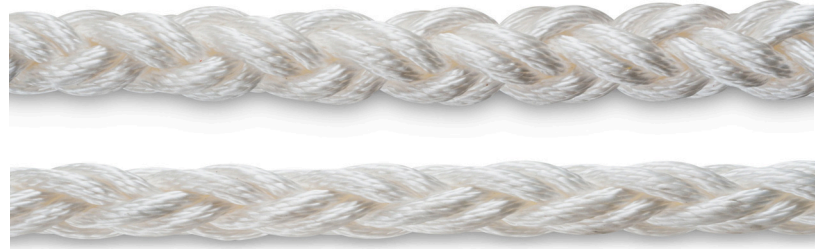
BRAIT LAY LENGTH CHANGE

Lay length change is normal over time, and a longer lay length in used rope can be seen due to repeated cyclic loading.

NEW

USED

This permanent deformation is caused by repeated cyclic loading.

If permanent deformation results in a longer lay length in excess of 15 percent, retire the line.
