Single Braid Inspection

SINGLE BRAID

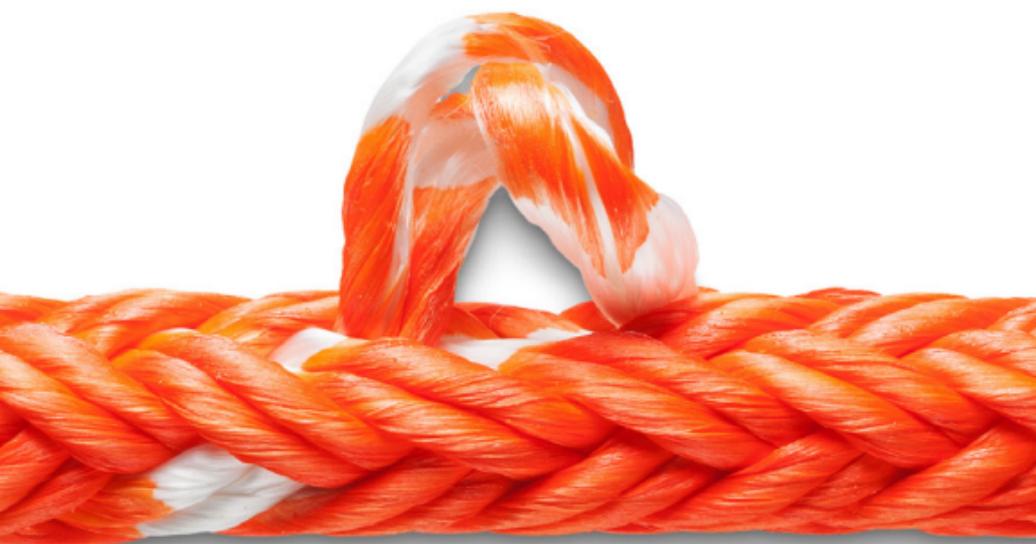
PROTRUDING STRAND

Often, a strand will get snagged or pulled out from the rest of the rope. As long as the strand isn't broken, this is a repairable issue.

Protruding strands are generally caused by pulling or snagging on equipment or surfaces.

Work the strand back into the rope as soon as you notice it by carefully tugging on adjacent strands until the excess is distributed evenly. A protruding strand in service could easily snag or break, causing further complications.

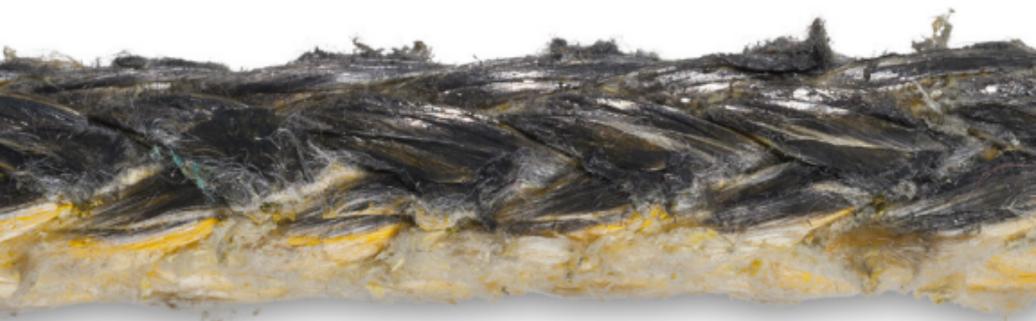
MELTING OR GLAZING

When fibers are melted or fused, it's generally the result of rope abuse, and this type of damage can compromise strength. Look for visibly charred fibers or strands and stiffness that is unchanged by flexing.

Melting or glazing is generally caused by excessive load weights, exposure to heat or rapid descents/shock loading.

If possible, remove the affected section and re-splice with an end-for-end splice. Otherwise – or if you suspect the rope has experienced shock loading – retire the rope.

Avoid shock loads. Always work within the energy absorption range of your rope, and be sure you're using the right rope for the job. Shock loading sometimes happens by accident – for example, if a loaded rope jumps over a wrap of the winding spool. Using the winch line (instead of pole jacks) to pull pole butts can also result in shock loading.

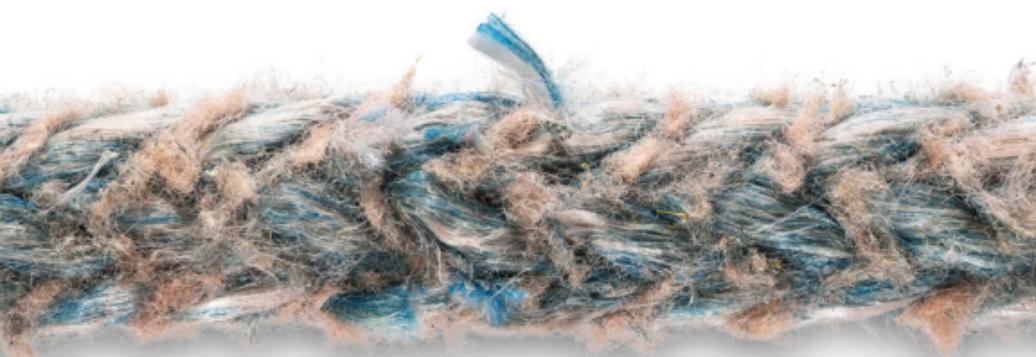
CUT STRAND

When visually inspecting your rope, always look closely for any cut strands. Any cut strands will cause some loss of strength, and two or more close together may mean the rope needs to be retired. This particular rope should be discarded due to its heavy abrasion.

Cut strands could be caused by abrasion, sharp edges and surfaces, or cyclic tension wear.

If possible, remove the affected section and re-splice with an end-for-end splice. If re-splicing is not possible, retire the rope. As a general rule, 12-strand ropes should be retired when more than three broken strands are visible.

Always use slings when lifting, and avoid abrasive situations whenever possible, including rough surfaces and sharp edges. Keep your chocks, bits, winches, drums and other surfaces in good condition and free of burrs and rust. Make sure sheaves are the right size and are free to rotate. Don't drag the rope over rough ground. Be sure to use clamps and similar devices with extreme caution.

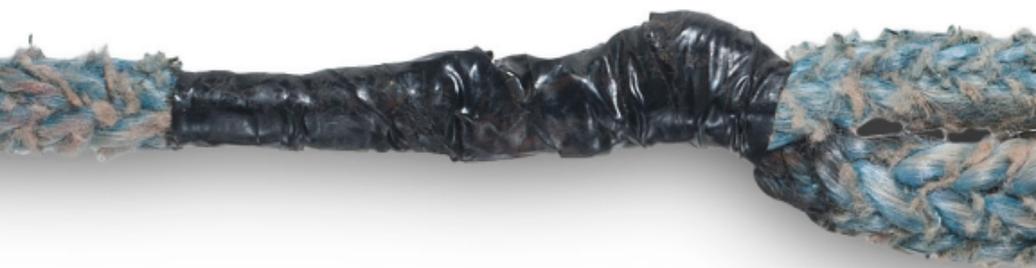
INCORRECT END-TO-END SPLICE

An incorrect end-to-end splice creates a disruption in the rope, to the extent that the rope's strength would be markedly reduced.

In this case, the user spliced the rope in the field without the benefit of proper splicing instructions, causing an incorrect end-to-end splice and significant disruption in the rope.

Re-splice the rope correctly.
